Rogue River Sediment Evaluation

SUBJECT: W.O.#92-SHM-181, Report of Soil Analyses

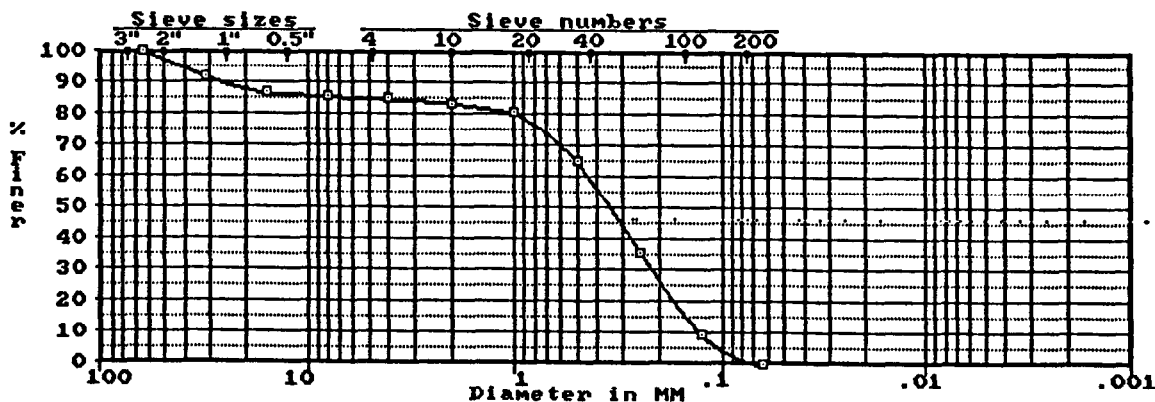
Boring: -- Sample: RR-P-5 Depth: -- Lab No.: 18119

D85: 5.14 D60: 0.44 D50: 0.34 D30: 0.22 D15: 0.15 D10: 0.13 mm
 Cu: 3.44 Cc: 0.85

Gravel: 15.1% Sand: 84.1% Fines: 0.8%

SP Poorly graded SAND with gravel

Sieve	Cumulative Grams Retained	Percent Passing
5 In.	0.00	100.0
2.5 In.	0.00	100.0
1.25 In.	215.10	92.0
5/8 In.	357.60	86.6
5/16 In.	388.10	85.5
No. 5	409.80	84.7
No. 10	445.00	83.4
Pan	2673.80	0.0
No. 18	6.45	80.4
No. 35	40.24	65.0
No. 60	104.13	35.9
No. 120	162.63	9.3
No. 230	183.00	0.0
Pan	183.03	0.0
